TESTREPORT

Report number 17.00927 rev.01

Subject Testing of "Finger alert Anti-slam".

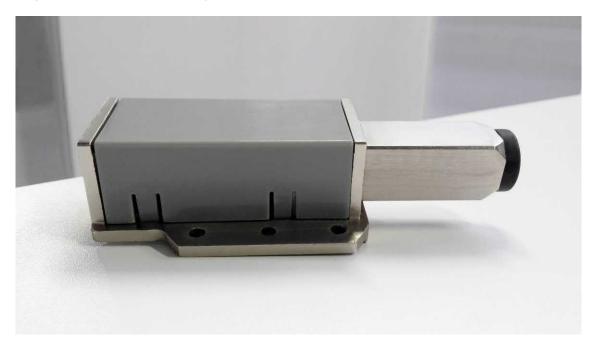
Finger protection device type: Finger-Alert ANTI-SLAM

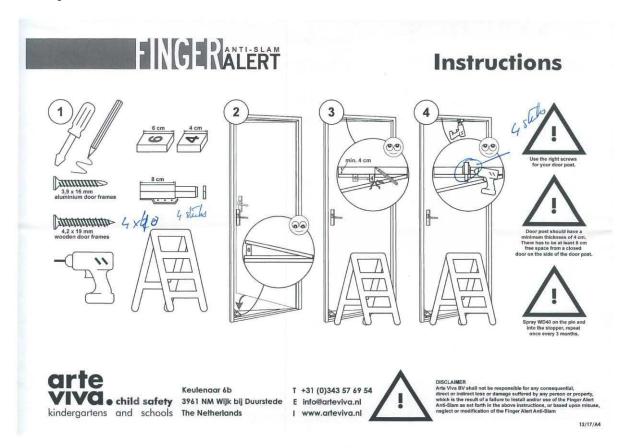
Mounting instructions:

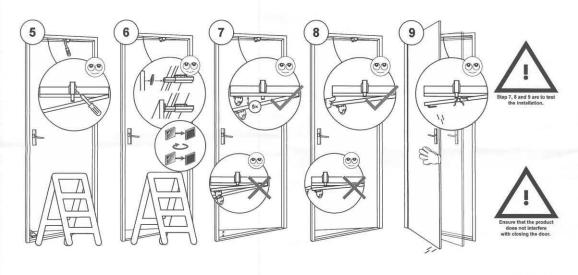
Instructions

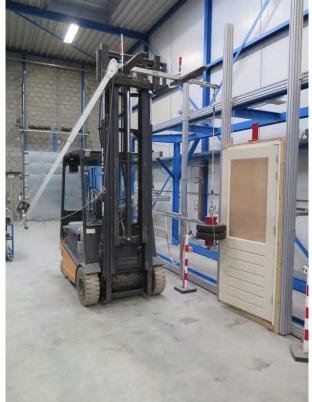
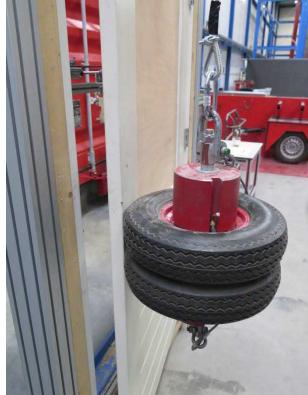
Functionality test: Impact on position of the lock

- Position of the door in opened position against the doorstopper, gap between door leaf and door frame 75 mm. impactor 50 kg at the position of the lock at 1,05 m.
- Drop height of 0.03m, W=(50x9.8)x0.03=14.7 J closing gap between door leaf and door frame 50 mm

- Durability of 250.000 cycles successfully accomplished.
- Position of the door in opened position against the doorstopper, gap between door leaf and door frame 75 mm. impactor 50 kg at the position of the lock at 1,05 m.
- Drop height of 0.03m, W=(50x9.8)x0.03=14.7 J closing gap between door leaf and door frame 50 mm

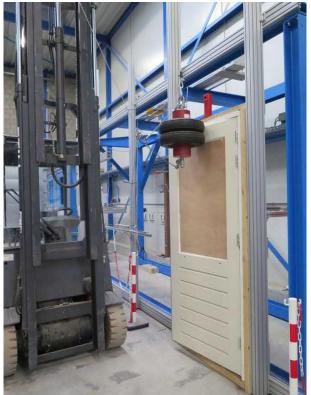
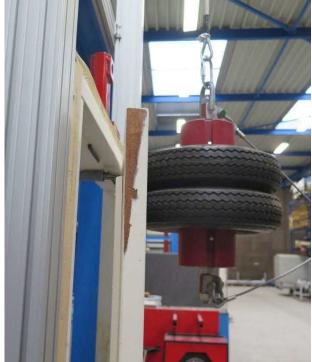
Strength and overload test: Impact on position of the stopper

- Dynamic test on the stopper, drop height 450 mm
- Stopper should still function after the test.
- Position of the door in opened position against the doorstopper, gap between door leaf and door frame
 75 mm. impactor 50 kg at the position of the doorstopper on the top of the door
- 1^{ste} impact: product enters into operation and is still fully functional
- 2nd impact: product enters into operation and is still fully functional
- 3rd impact: product enters into operation but blocks and doesn't function anymore.

- Tested with a new sample for every test.
- Position of the door in opened position against the doorstopper, gap between door leaf and door frame
 75 mm. impactor 50 kg at the position of the doorstopper on the top of the door
- 750 mm drop height: 367.5 Joule impact, product enters into operation but blocks and doesn't function anymore
- 1100 mm drop height: 539 Joule, product enters into operation but blocks and doesn't function anymore
